FIELD EVALUATION OF DROP-CHECK STRUCTURES FOR FARM IRRIGATION SYSTEMS

March 1971 ARS 41-180

Agricultural Research Service

A. S. Humpherys and A. R. Robinson[2]

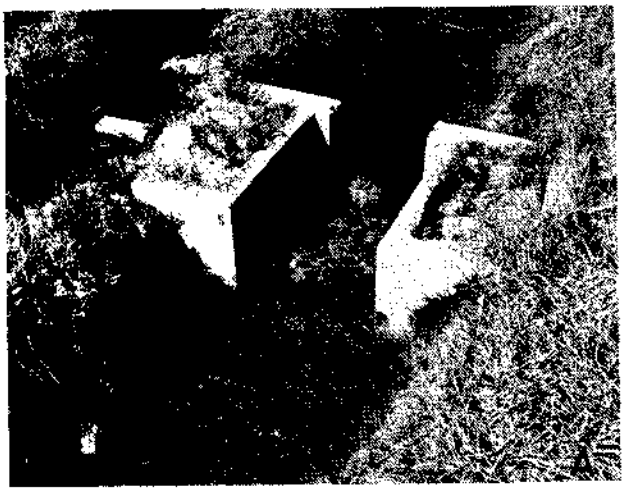
Structure 5: Vertical crack in wingwall.

Figure 12.–Standard design, cast-in-place concrete, rectangular-basin structure with an end sill, Nos. 4, 5: A, In operation. B, At the end of the study.

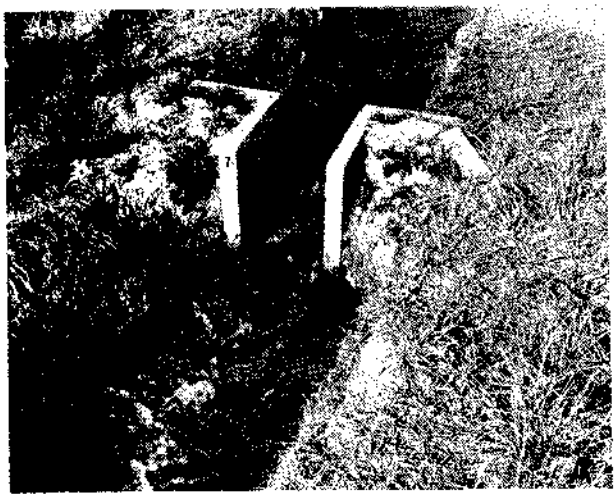
Structure 7: Longitudinal cracking in the corners of the basin at the base of the sidewalls.

Figure 14.--Precast concrete structure without an end sill, Nos. 7, 18: A, In operation. B, At the end of the study.

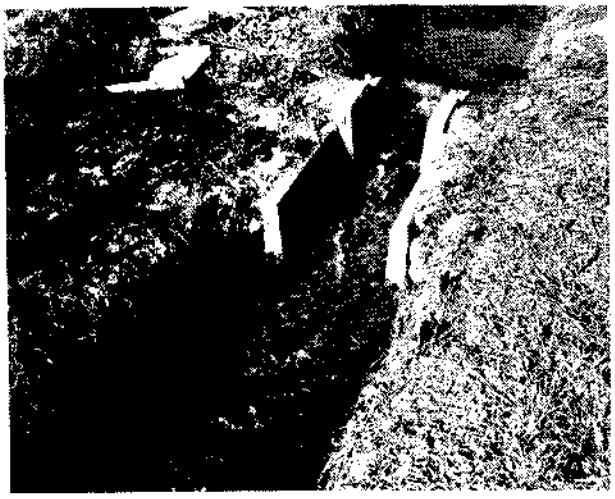
Structures 8, 9, and 10: Cracking and spalling on the top of the center section.

Figure 15.–Small-size precast concrete structure with upstream cofferdam and downstream liner section, Nos. 8, 9, 10: A, In operation. B, At the end of the study.

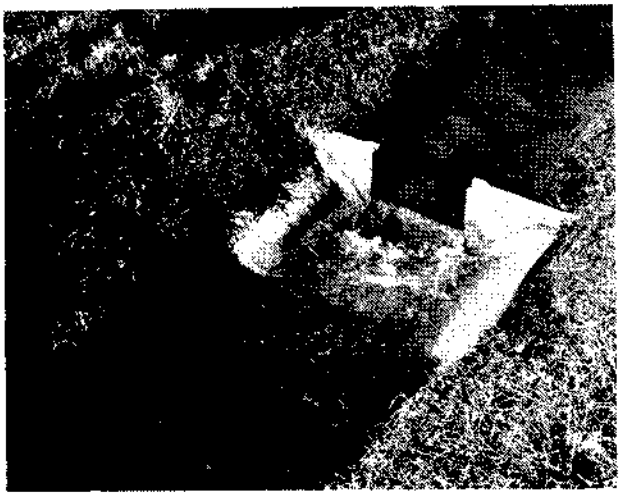
Structures 11 and 12: Separation of the fiber glass basins from the concrete headwalls.

Figure 16.–Precast concrete-headwall structure with fiber glass stilling basin, Nos. 11 and 12: A, In operation. B At the end of the study.

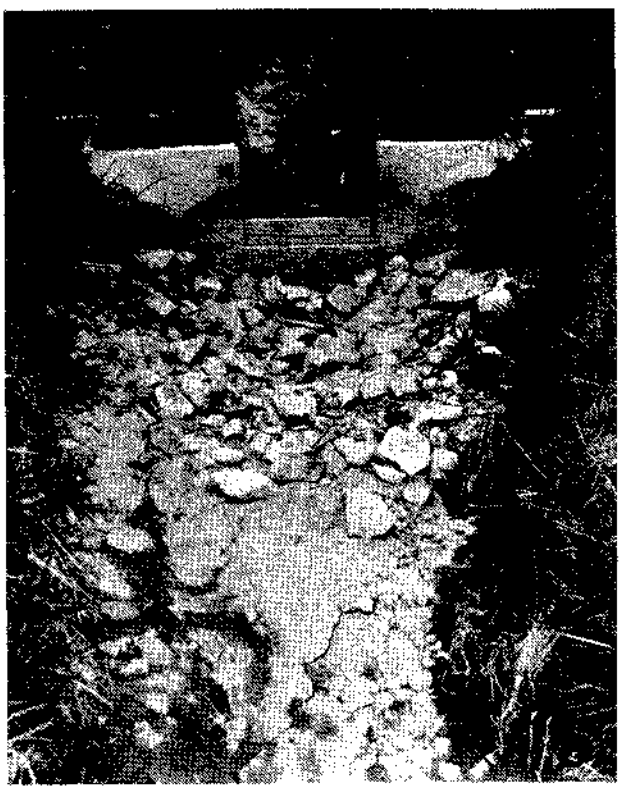
Figure 17.–Precast concrete-headwall structure with steel-lined stilling basin, Nos. 13, and 14: A, In operation. B, At the end of the study.

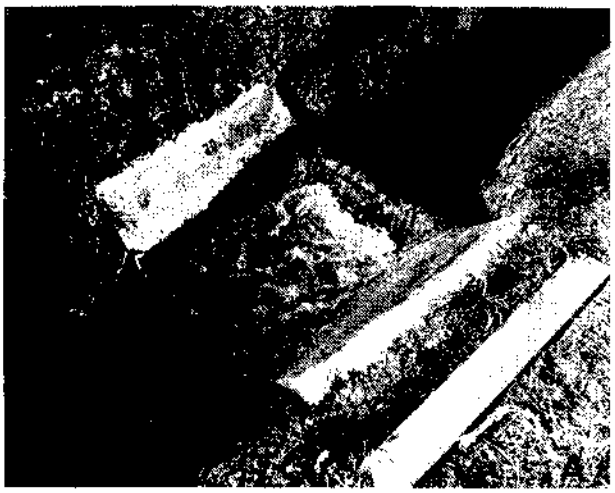
The difference in tailwater depth noted previously between structures 19 and 20 accounts for the large difference in scour depth and erosion volume for these structures, which are of the same design. The difference in scour volume and performance is significant and emphasizes the importance of adequate tailwater depth for this type of structure. Channel degradation below structure 19, which had shallow tailwater, is shown in figure 8.

Figure 19.–Standard design, cast-in-place concrete structure with trapezoidal basin, Nos. 19 and 20: A, In operation. B, At the end of the study.

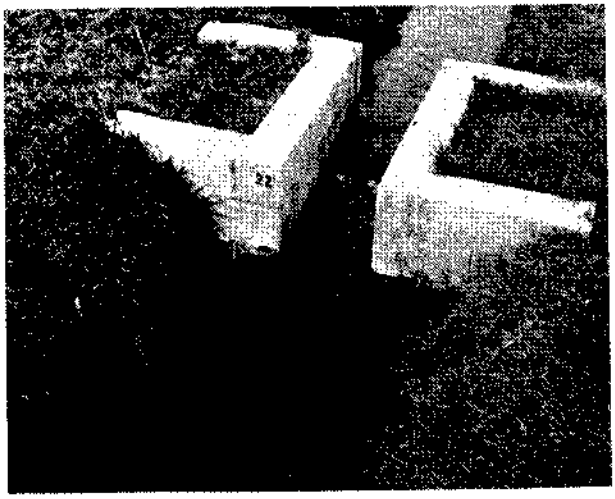
(5) With adequate tailwater depth, a trapezoidal stilling basin gave good hydraulic performance. Without sufficient tailwater, the performance was poor and high velocity caused excessive downstream erosion.

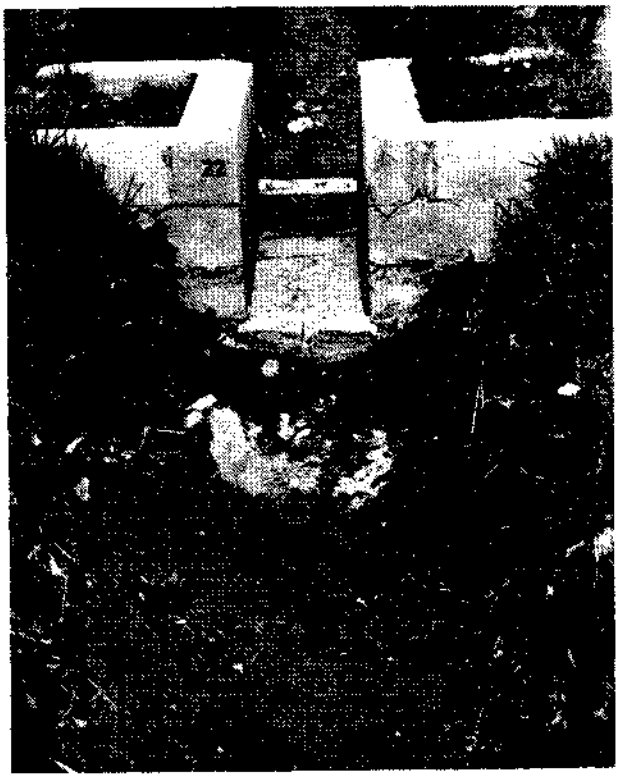
Structure 21: Block cracking, some joint separation and longitudinal block cracking near the base of the concrete-block sidewalls.

Structure 22: Block cracking, some joint separation and longitudinal block cracking near the base of the concrete-block sidewalls, transverse cracking of the basin floor at each end, separation of the basin floor from the sidewalls, and end-sill break.

Figure 20.--Standard design, concrete-block structure with rectangular basin, Nos. 21 and 22: A, In operation. B, At the end of the study.

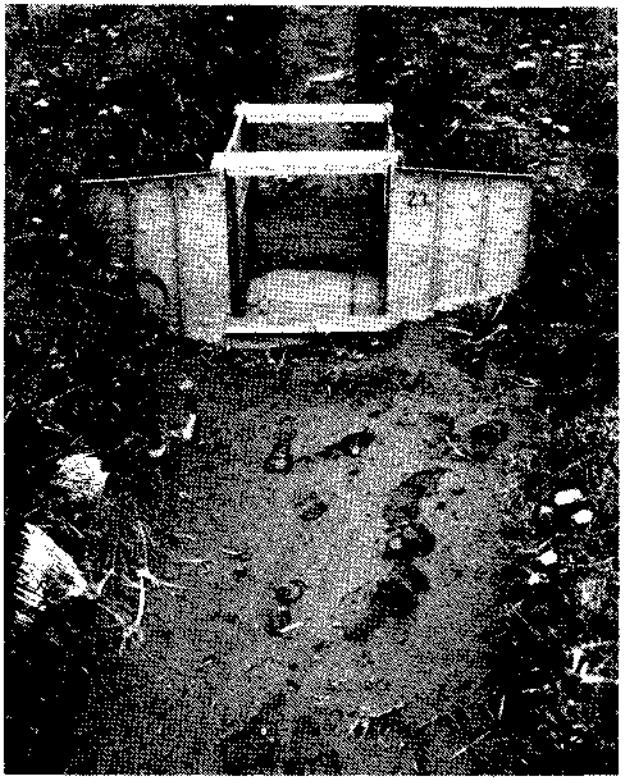
Metal modular structure 23 (see Appendix, fig. 21) originally had a narrow opening and a narrow stilling basin. At the beginning of the 1968 season, it was removed and rebuilt to provide a wider and longer basin with a longer crest. The scour hole that had developed downstream during the first two seasons was filled. Extending the crest length and basin width did not entirely correct its faulty performance. Flanges on the vertical edges of the modular components protruded into the stream and apparently altered the pressure distribution near the end of the basin. At some discharges, the water was observed to flow almost 90° laterally at the downstream end of the structure. The high end sill in structure 23 also appeared to contribute to strong turbulence, which persisted even with an increased tailwater depth. Because of the lateral velocity currents, considerable erosion and channel widening continued downstream after the original scour hole was refilled. This structure washed out several times during the course of the study, and considerable maintenance was required around the ends of the wingwalls.

Figure 21.–Commercial, modular-steel structure with water checked to give increased tailwater depth, No. 23: A, In operation. B, At the end of the study.

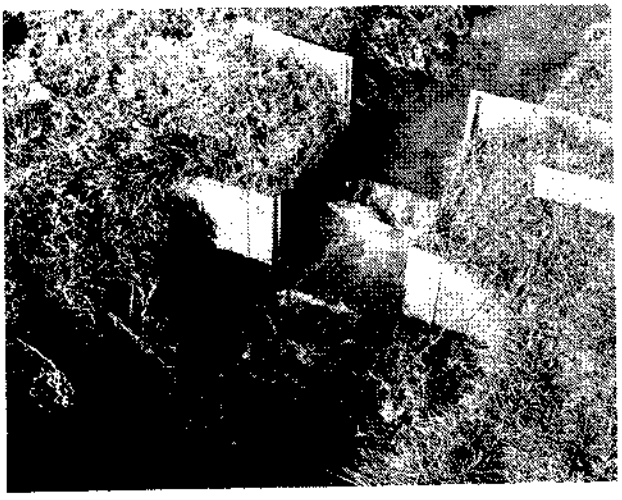
The stilling basins for metal modular structures 24 and 30 were too short to provide adequate energy dissipation. The apron of structure 30 was extremely short, and strong turbulence occurred downstream over the unprotected soil; however, an apparent hardpan in this area reduced the scouring. This structure was designed and installed by the local dealer as it is normally used in the area. Consequently, the apron was very short and wingwalls were not provided. Erosion occurred beneath the basin and behind the sidewalls extending upstream to the headwall. This caused the structure to fail by undermining one side of the headwall. A construction flange at the end of the basin on the bottom and sides of structure 24 appeared to contribute to the formation of eddy currents similar to those at the end of structure 23. Vortices and eddy currents tended to form at the downstream corners of all basins having 90° wingwalls, but they were stronger and more pronounced with basins having sills and protruding flanges. Because the metal panels are driven into the soil, structures similar to 24 and 30 are normally resistant to piping and washouts.

Figure 22.–Commercial, modular-aluminum structure, special design, No. 24: A. In operation. B. At the end of the study.

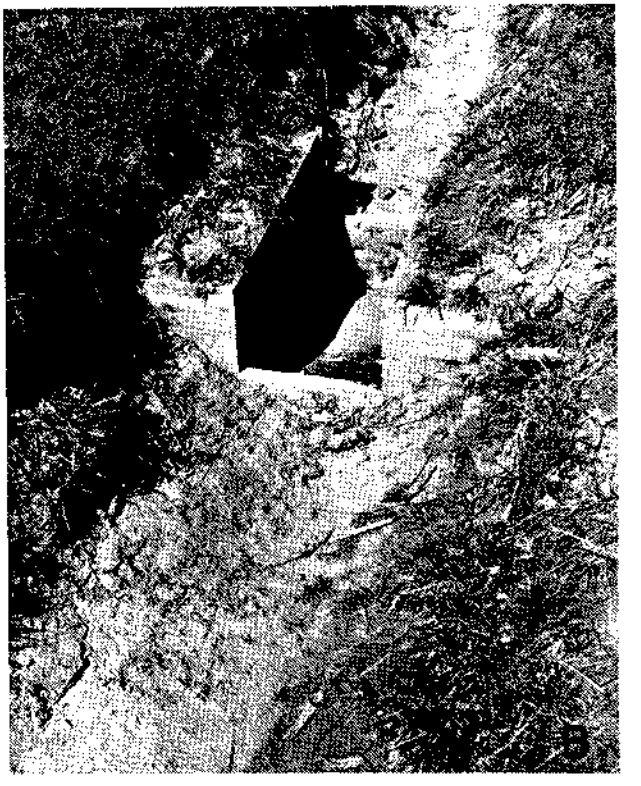
Structure 31: Checking of the wood.

After the study was initiated, a culvert was installed downstream from structure 31. This resulted in an increased tailwater depth, and the structure operated partly submerged except when the flow was very small. Even though partly submerged much of the time, the narrow basin, combined with turbulence over the end sill, caused considerable erosion and stream channel widening immediately downstream.

Figure 26.–Standard design wooden structure, No. 31: A, In operation. B, At the end of the study.
